Remote inspection of RC structures using unmanned aerial vehicles and heuristic image processing

This article describes an innovative methodology for remote inspection of reinforced concrete (RC) structures using Unmanned Aerial Vehicles (UAVs) and based on advanced digital image processing. The use of specific heuristic feature-extraction methods, developed in MATLAB®, allows the automatic identification of various types of RC pathologies, particularly, biological colonies, efflorescences, cracks and exposed steel rebars. The developed inspection methodology is applied to the Monte da Virgem telecommunications tower, which has a total height of 177 m and is the highest structure of this kind in Portugal. The results demonstrate the efficiency and robustness of the methodology in: i) its ability to accurately locate and characterize the existing pathologies, ii) visualizing the full extent of pathologies in 3D photogrammetric reconstitutions of the structure, and iii) integrating the identified pathologies into a Building Information Modeling (BIM) model. The regular use of the proposed methodology over time will allow accurate monitoring of the evolution of pathologies to assess

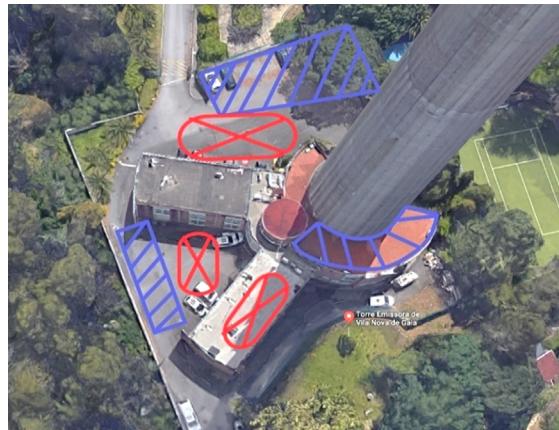
Fig. 8. Flight plan: observation zones (in blue) and take-off/landing zones (in red).

The flight technique that was used was manual flight due to the following constraints: i) possible signal interference from the

transmitting equipment operating in the tower, ii) the existence of trees near the base of the tower, iii) the complex geometry of the tower's surface, in the form of a hyperboloid of revolution, hindering the programming of automatic flights, and iv) due to the proximity of the coastline, the wind and the possible attack of birds, mainly seagulls, posed a threat to flight safety.

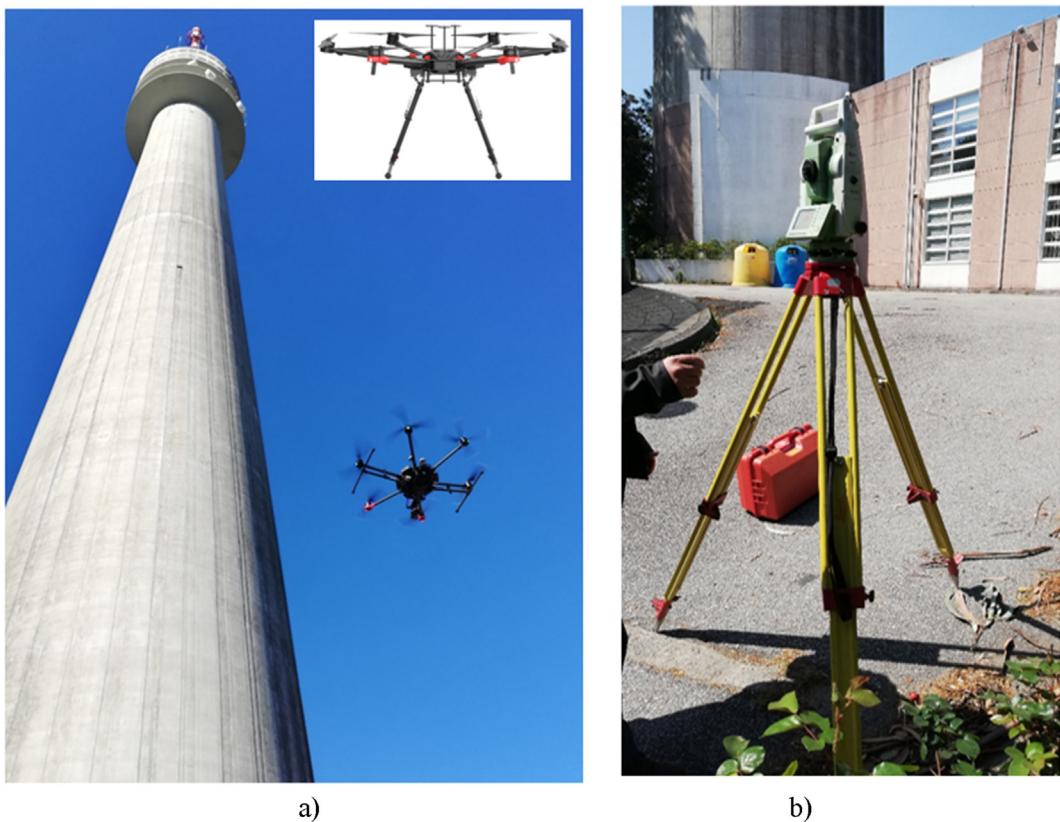
The image collection was performed with a professional drone, namely a DJI Matrice 600 Pro (Fig. 9a). The DJI Matrice 600 Pro is a hexacopter weighing between 9.5 kg and 10 kg, with a maximum recommended take-off weight of 15.5 kg, a maximum horizontal speed of 65 km/h, a maximum service ceiling of 2500 m above sea level and an estimated flight autonomy of approximately 30 min (per battery set). The camera installed in the drone was a gimbal mounted DJI Zenmuse X5, with a MFT 15 mm focal length f/1.7 aspherical lens, a 16MPx resolution and a sensor with an imaging area of 17.3 mm × 13.0 mm (21.6 mm diagonal). The gimbal used ensures image stabilization along the three axes. The visualization of the images and the remote control of the drone were carried out by means of a DJI Matrice 600 Series remote controller and a high-resolution tactile DJI Crystal Sky monitor, with internal image storage capacity.

Fig. 9. UAV image collection: a) DJI Matrice 600 Pro in operation, b) topographic survey.

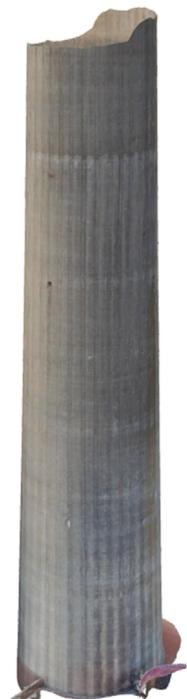
Fig. 10. Global perspective of the 3D geometric model of the structure reconstituted in Pix4Dmapper software.

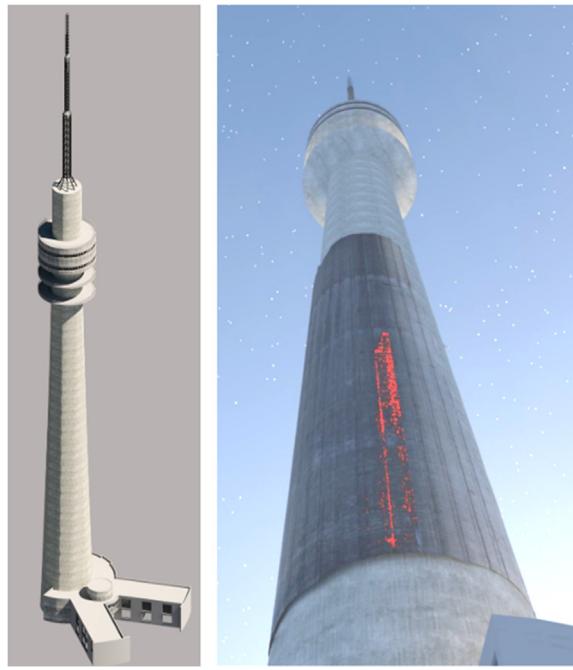
A 3D geometric model of the tower, including the material properties and the phasing of the construction process, was developed in the Autodesk Revit platform (Fig. 14). The geometric generation of the concrete shaft was performed with the aid of the graphical programming tool Dynamo, considering the limitations of Revit regarding the autonomous generation of the wall in the shape of a hyperboloid of revolution. The geometry and structural properties of the metallic tower were imported from an existing numerical model developed in the Autodesk Robot software [37]. The masks of the various identified pathologies were incorporated into the BIM model using the Autodesk Navisworks software. As an example, Fig. 14 depicts the biological colonies mask on the external layer of the tower shaft, between the 30 m and 60 m levels.

Fig. 14. BIM model of the tower with the biological colonies mask.
