Technical Report - MACKENZIE PRESBYTERIAN UNIVERSITY

Safety and Deflagration Tests of Lithium Batteries for Stationary Residential Use

Scope: This report presents a comparative evaluation of four lithium-ion battery technologies subjected to thermal, electrical, and fire-simulated stress conditions. The analysis documents the progression of thermal runaway, characterizing such as gas venting, flame development, and the occurrence of explosions.

Report Number: HU08

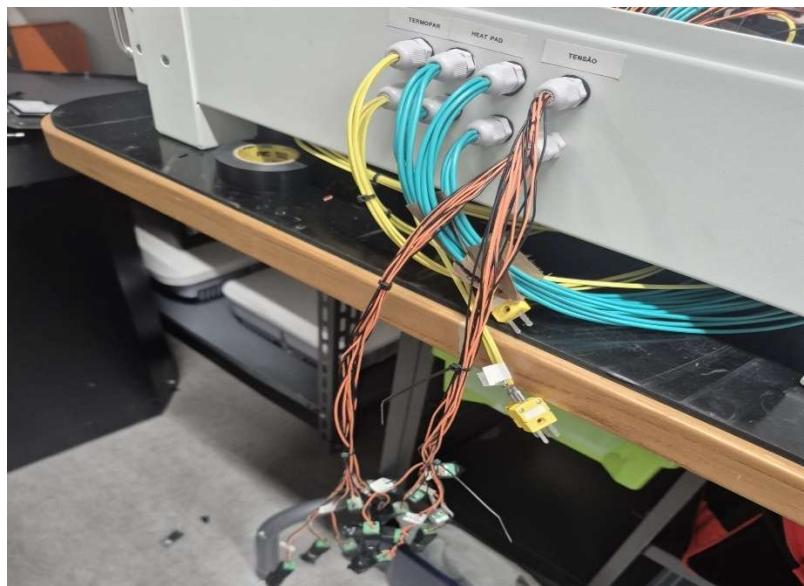
Figure 1 presents an example of the cabling after the implementation of the heat pads, thermocouples and voltage measurement, yellow cables were used for the thermocouple's measurement, green for heat pad connection to external DC power supply and orange/black for voltage measurement. Also, Figures from 2 to 5 presents the batteries internal cell distribution diagram, with the location of heat pads, thermocouples, voltage measurement and indication of the overloadable cell.

Figure 1 – Cables for battery evaluation during tests.

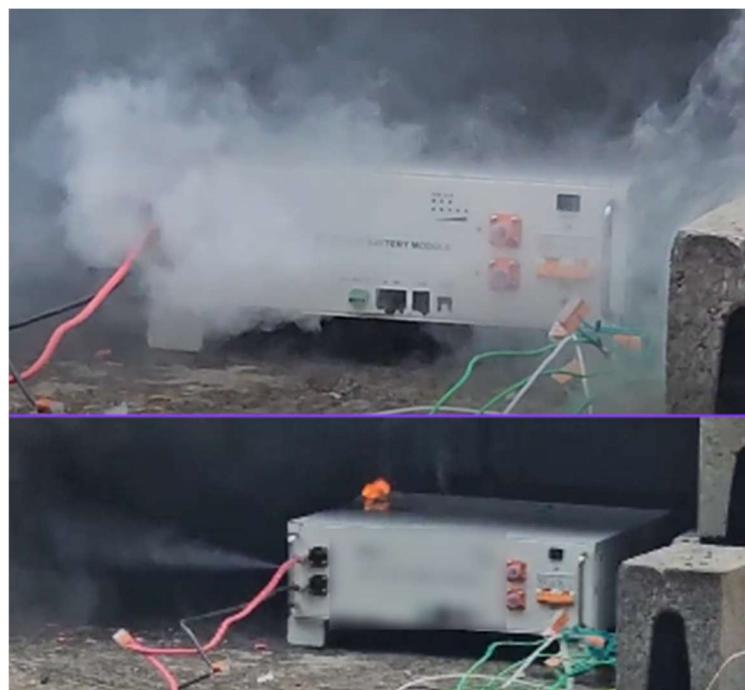
Figure 8 shows Battery A during the thermal runaway event. The flames on Battery A were started by the battery internal short-circuit, as indicated by audible arcing sounds during the events

Figure 8 – Visual Record of Thermal Runaway and Deflagration (Battery A).

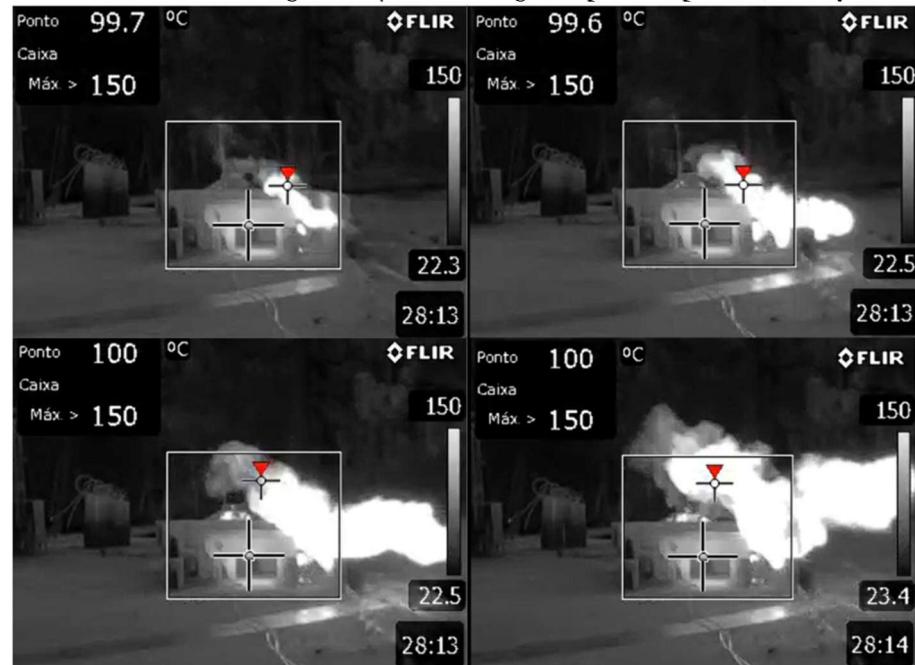
The thermal behavior during the only jet fire registered on Battery B is documented in Figure 13 via IR imaging where high-temperature flammable gases are expelled from the battery unit.

The IR signature shows a concentrated thermal plume extending horizontally from the battery.

Figure 13 – Infrared recording of the jet fire and gas expulsion phase (Battery B – Day 3).

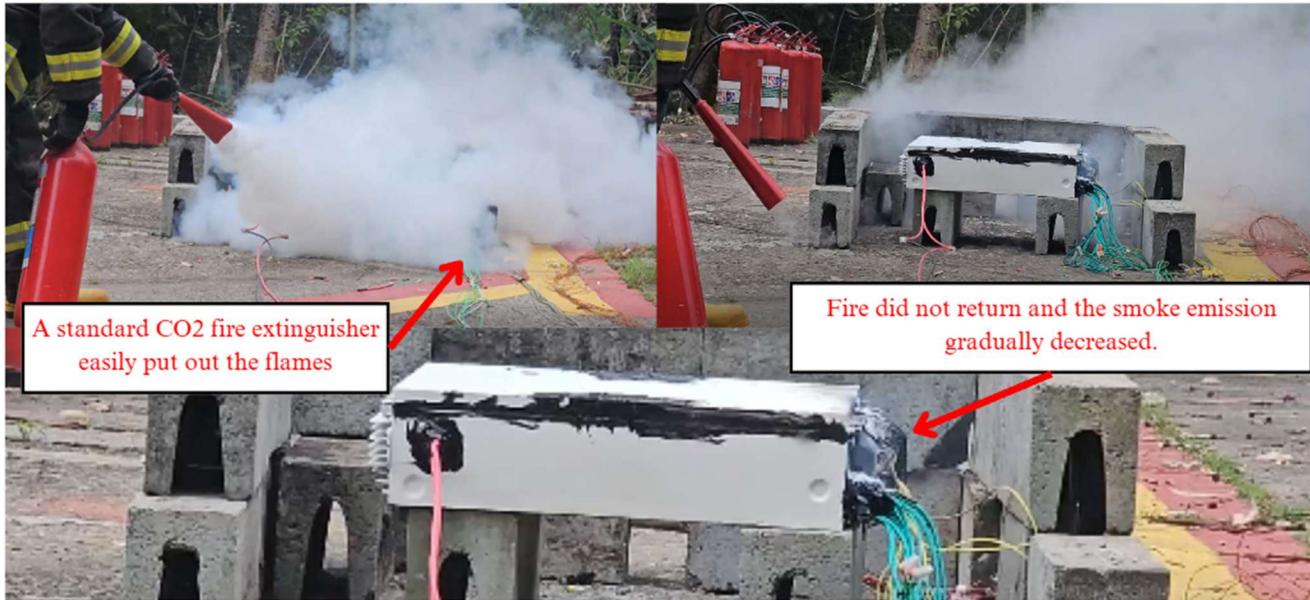
Following the thermal runaway and subsequent deflagration of Battery B, a fire extinguisher was utilized to suppress the active flames. As documented in Figure 14, the fire did not reignite after the initial intervention. Following the suppression of the flames, a gradual and continuous reduction in smoke emission from the battery unit was recorded.

Figure 14 – Firefighter suppressing the fire using a extinguisher no Battery B.

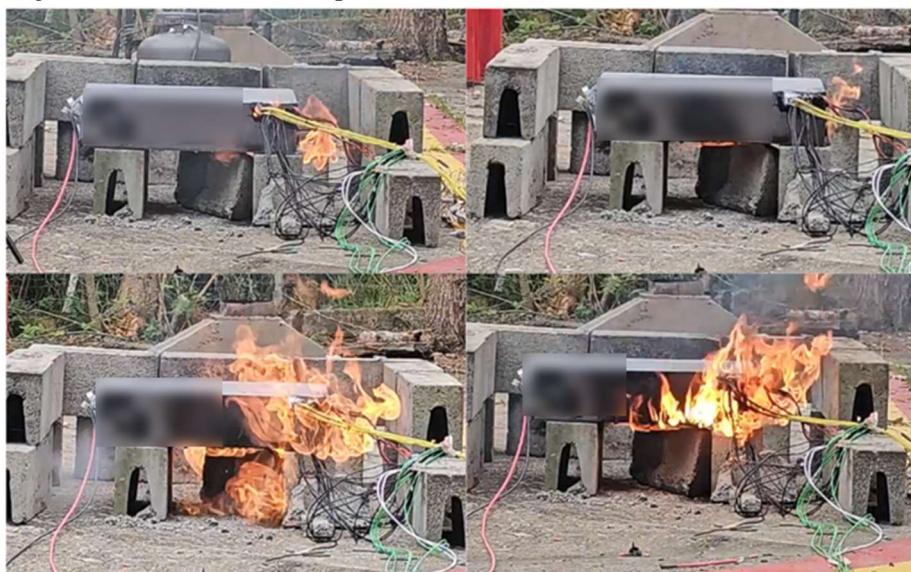
The progression of combustion in Battery C is documented in Figure 17, following the initial ignition phase. The Figure records the expansion of the flames across the external casing of the unit. During this stage, the fire reaches the measurement cables. The subsequent frames show the sustained burning of the instrumentation components as the fire intensifies.

Figure 17 – Progression of flames and impact on the measurement instrumentation (Battery C – Day 3).

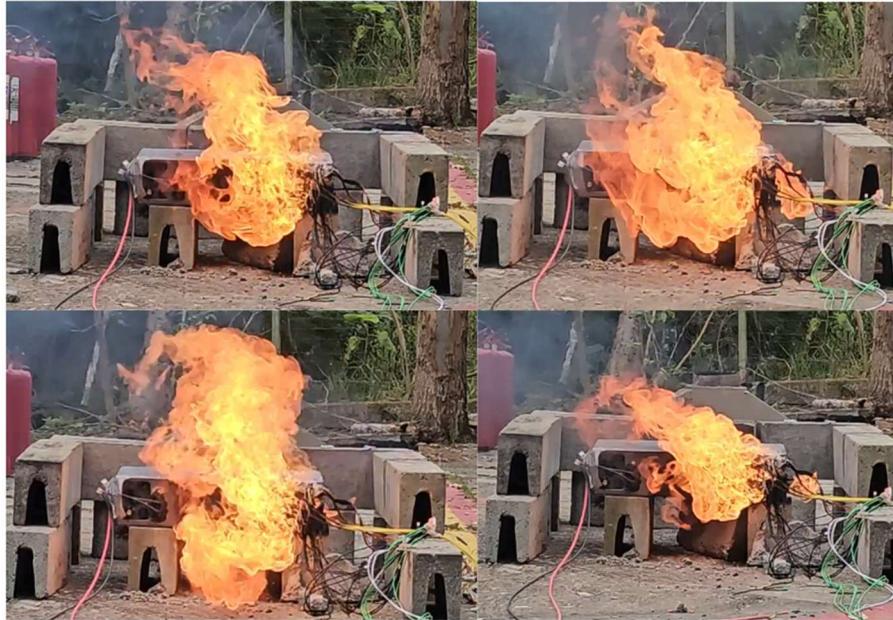
Figure 18 documents the further progression of the thermal event in Battery C, where the combustion process intensifies. As the internal cells deteriorate, the unit exhibits a sequence of multiple explosions, these reactions are accompanied by sustained jet fires.

Figure 18 – Visual record of multiple explosions and jet fire (Battery C – Day 3)

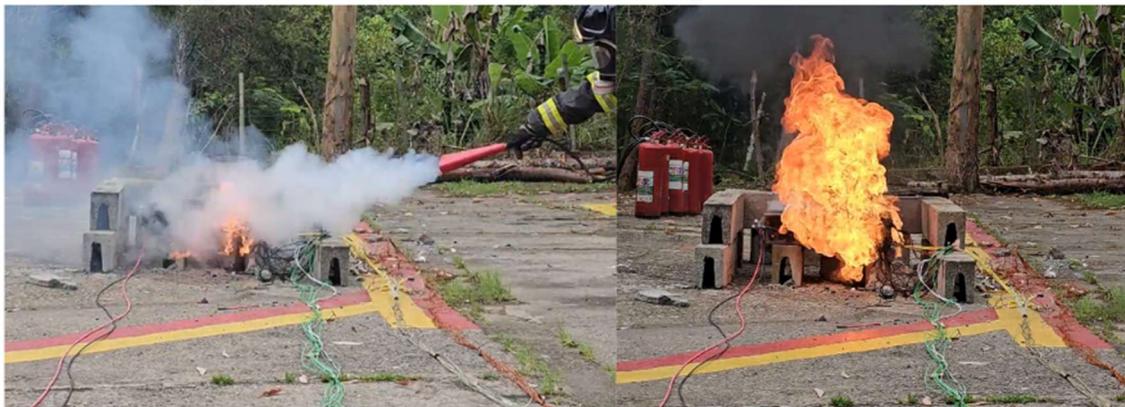
The sequence in Figure 19 documents the initial fire suppression attempt for Battery C using a fire extinguisher. The first intervention was unsuccessful in permanently extinguishing the flames. Following the initial discharge, the combustion intensified, and additional internal explosions were recorded within the battery.

Figure 19 – Initial fire suppression attempt on Battery C and subsequent intensification of flames and explosions.

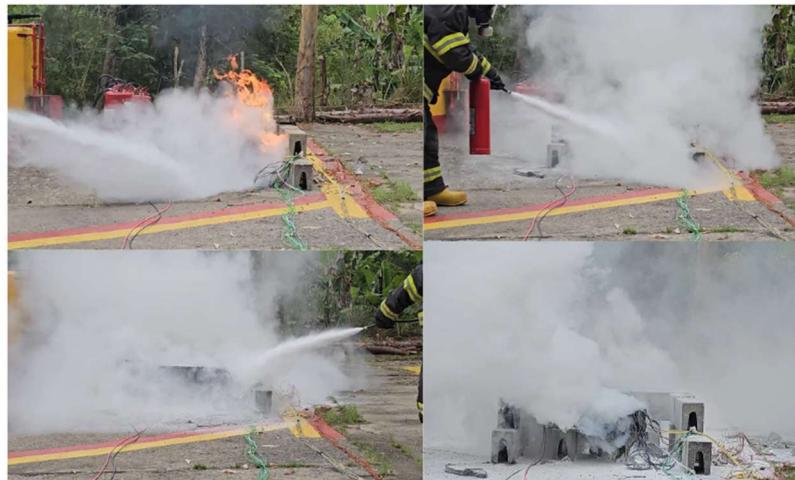
As documented in Figure 20, the second fire suppression attempt successfully extinguished the visible flames on Battery C. Despite the extinction of the active fire, continuous smoke emission from the battery was recorded following the second intervention.

Figure 20 – Successful extinction of visible flames and subsequent continuous smoke emission (Battery C – Day 3).

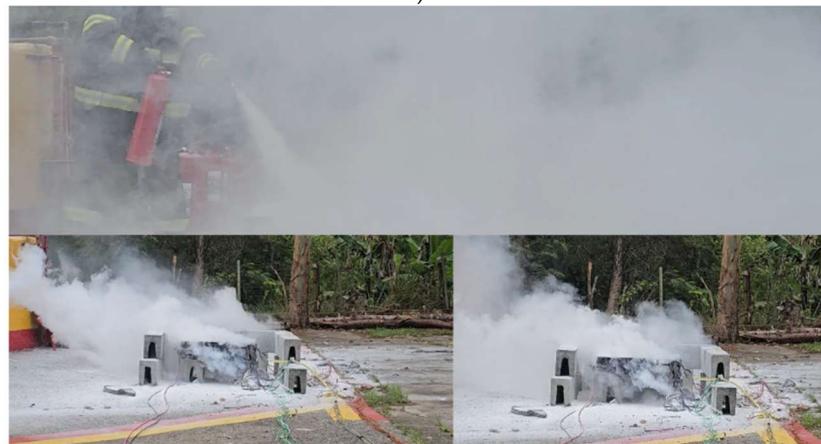
As shown in Figure 21, a third intervention was performed by the firefighter with the objective of reducing smoke emission from Battery C. While a temporary decrease in emissions was recorded following this attempt, smoke production re-intensified after a brief period.

Figure 21 – Third intervention for smoke mitigation and subsequent re-intensification of emissions (Battery C – Day 3).

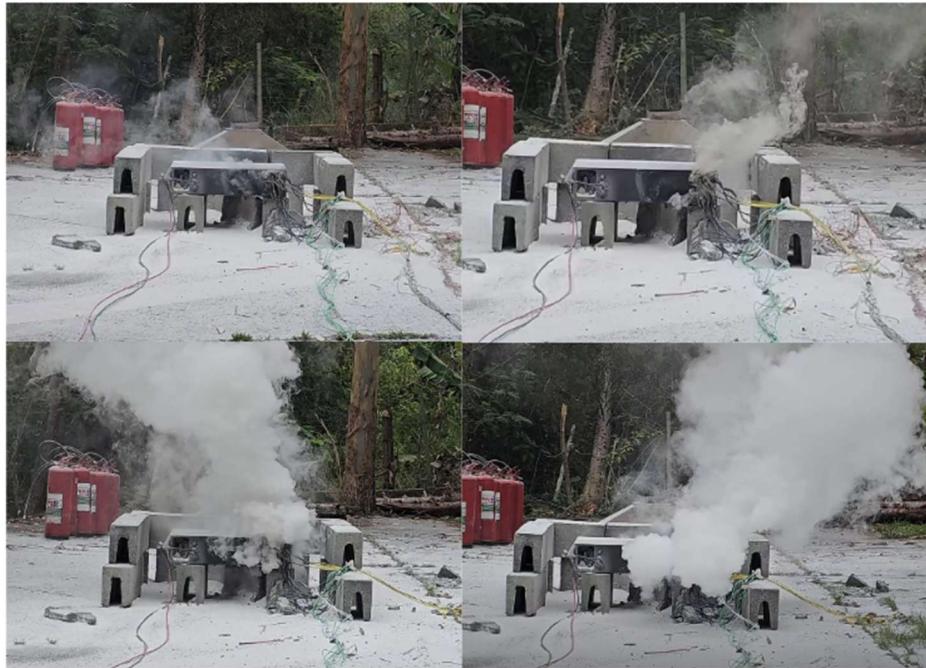
Following the fourth suppression attempt, Figure 23 documents the subsequent behavior of Battery C. The upper panels of the figure illustrate a temporary reduction in smoke emission following the fourth intervention. However, after a brief interval, as shown in the lower panels, the emission of smoke re-intensified.

Figure 23 – Observation of temporary smoke reduction (top) followed by re-intensification (bottom) after the fourth suppression attempt (Battery C – Day 3).

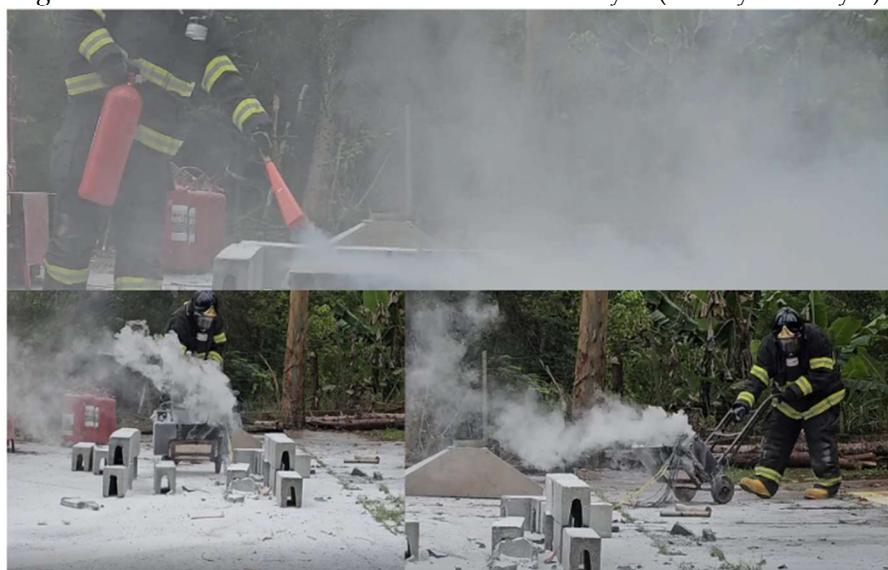
Figure 24 documents the fifth intervention, performed by the firefighter with the objective of cooling Battery C to facilitate its safe removal and transport the unit to a separate location for stabilization. In this designated area, foam was utilized to complete the cooling process and ensure the termination of internal exothermic reactions.

Figure 24 – Fifth intervention for removal of Battery C (Battery C – Day 3).

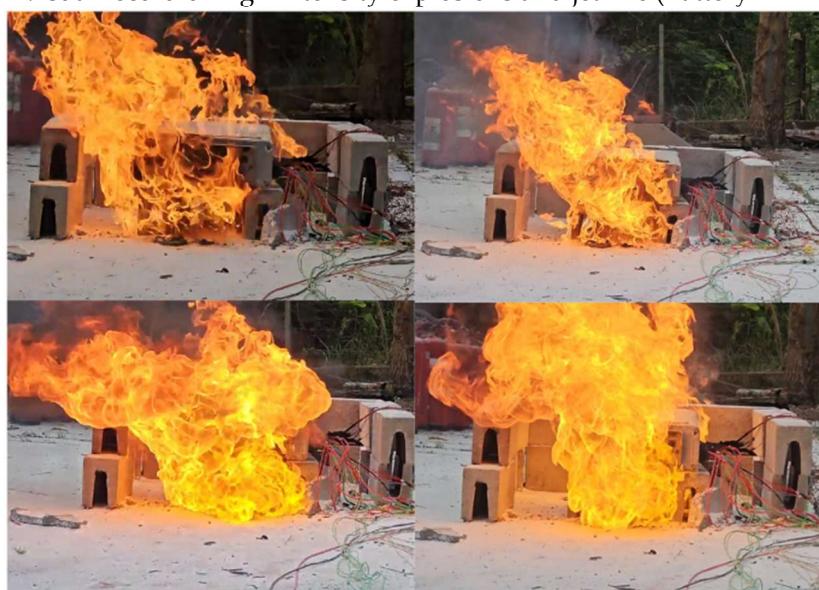
Battery D maintained its structural integrity for approximately 65 minutes before entering the state of thermal runaway, the equipment exhibited a sequence of explosions and jet-fire. Based on comparative observations during the POC, these events demonstrated the highest intensity among all tested units, characterized by rapid energy release and the formation of large-scale flames, figure 26 shows multiples explosions recorded.

Figure 26 – Visual record of high-intensity explosions and jet-fire (Battery D – Day 3)

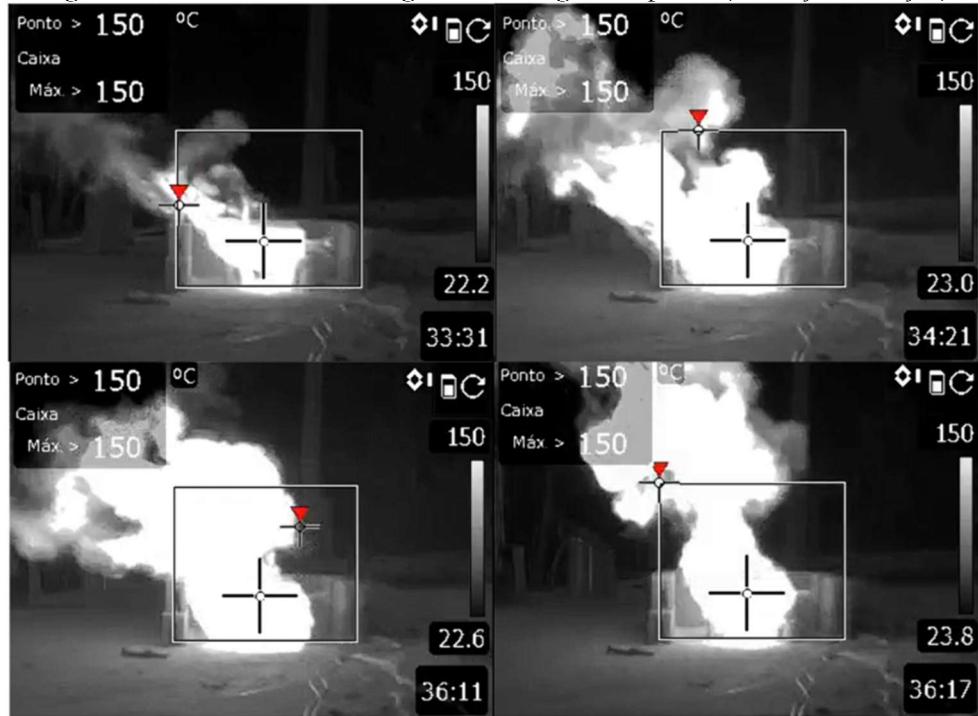
The infrared recording in Figure 27 documents thermal behavior during the deflagration of Battery D. The imaging captures various explosions plumes at different intervals.

Figure 27 – Infrared monitoring of the deflagration phase (Battery D – Day 3)

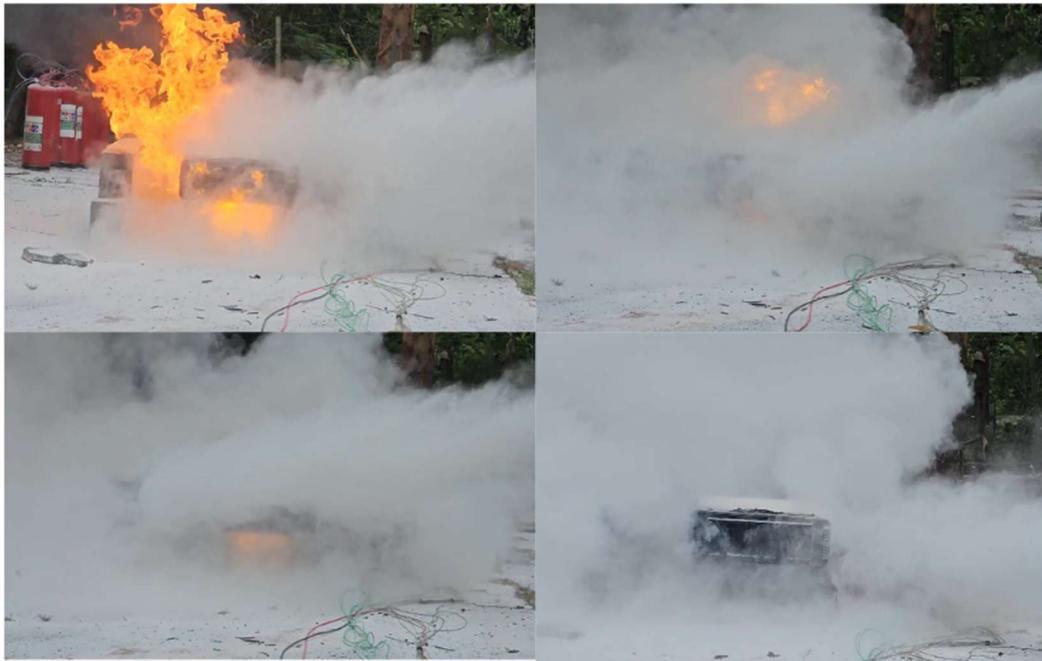
Figure 28 shows the active fire in Battery D was successfully suppressed during the initial intervention by the firefighter and did not reignite. However, the high volume of smoke emission following the extinction of visible flames necessitated multiple subsequent interventions for mitigation. This requirement for repeated suppression attempts to manage persistent gas and smoke release mirrors the behavior previously observed during the tests for Battery C.

Figure 28 – Successful initial fire suppression and subsequent interventions for smoke mitigation (Battery D – Day 3).
